SELECTED DESIGN NOTES

LANDING GEAR — Hydraulic Brake Control Valve

Corrosion Caused Frequent Readjustment of Brake Control System

BULLETIN NO. 55-11

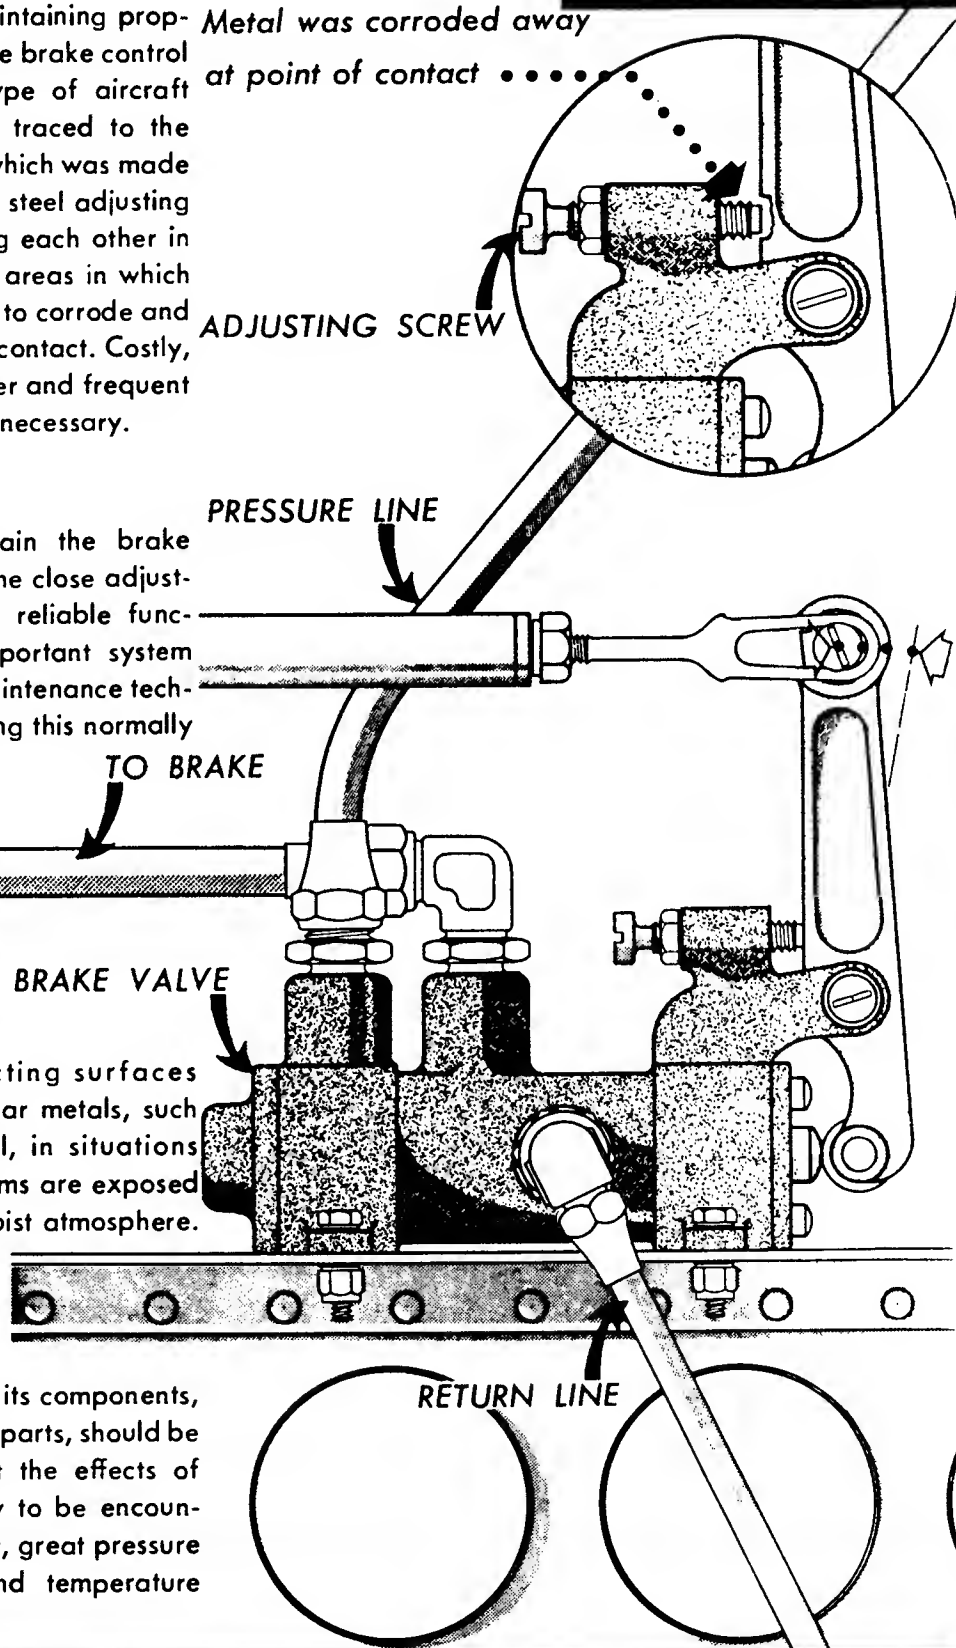
CONSIDERABLE DIFFICULTY was experienced in maintaining proper adjustment of the brake control systems of one type of aircraft used by an airline. The trouble was traced to the hydraulic pressure control valve lever which was made of an aluminum alloy in contact with a steel adjusting screw. The dissimilar metals contacting each other in the presence of moist sea air in some areas in which the aircraft operated, caused the lever to corrode and be rapidly eaten away at the point of contact. Costly, time-consuming replacement of the lever and frequent readjustment of the brake system was necessary.

*Metal was corroded away
at point of contact*

Exposed contacting surfaces should be of similar metals, such as stainless steel, in situations wherein mechanisms are exposed to electrolytic action of salt-laden, moist atmosphere.

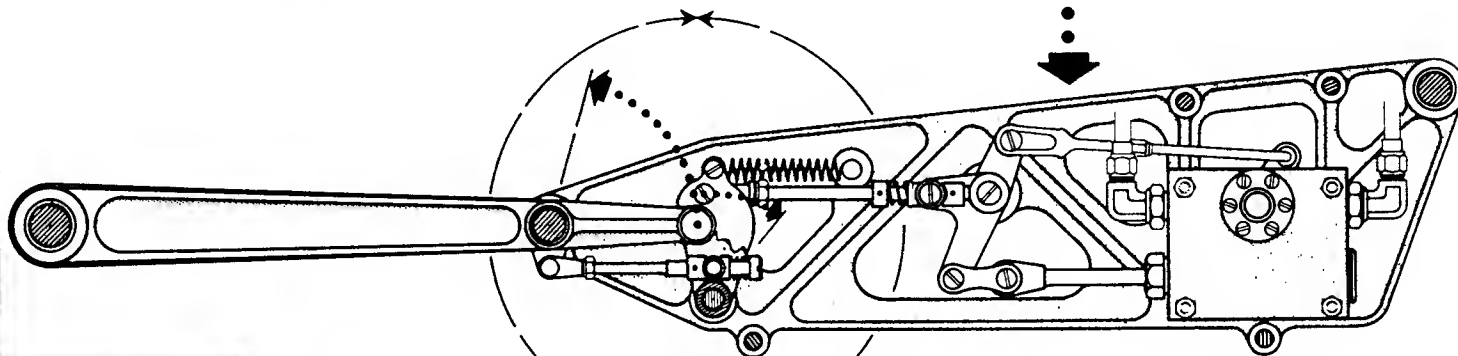
DOWNLOCK CONTROL MECHANISM

CONSIDERABLE DAMAGE to a large transport was inflicted when one of the main landing gear units retracted inadvertently during the landing roll. Investigation revealed the downlock actuating rod had snapped due to fatigue failure of the threaded portion above the lock nut causing the locking mechanism to remain unlatched.

Failure of rod ends exposed to vibration is a frequent occurrence when the length adjusting portions of the rods are designed with sharp V threads being specified. Stress concentrations occur in the sharp corners resulting in eventual fatigue failure if conditions are such as to subject mechanisms to excessive vibration.

Fatigue failure occurred in sharp V threads making latch closure impossible

Rods designed with rolled threads or threads otherwise produced having slightly rounded corners, are better able to withstand stresses which ordinarily would induce fatigue than threads machined with unrelieved, sharp corners.

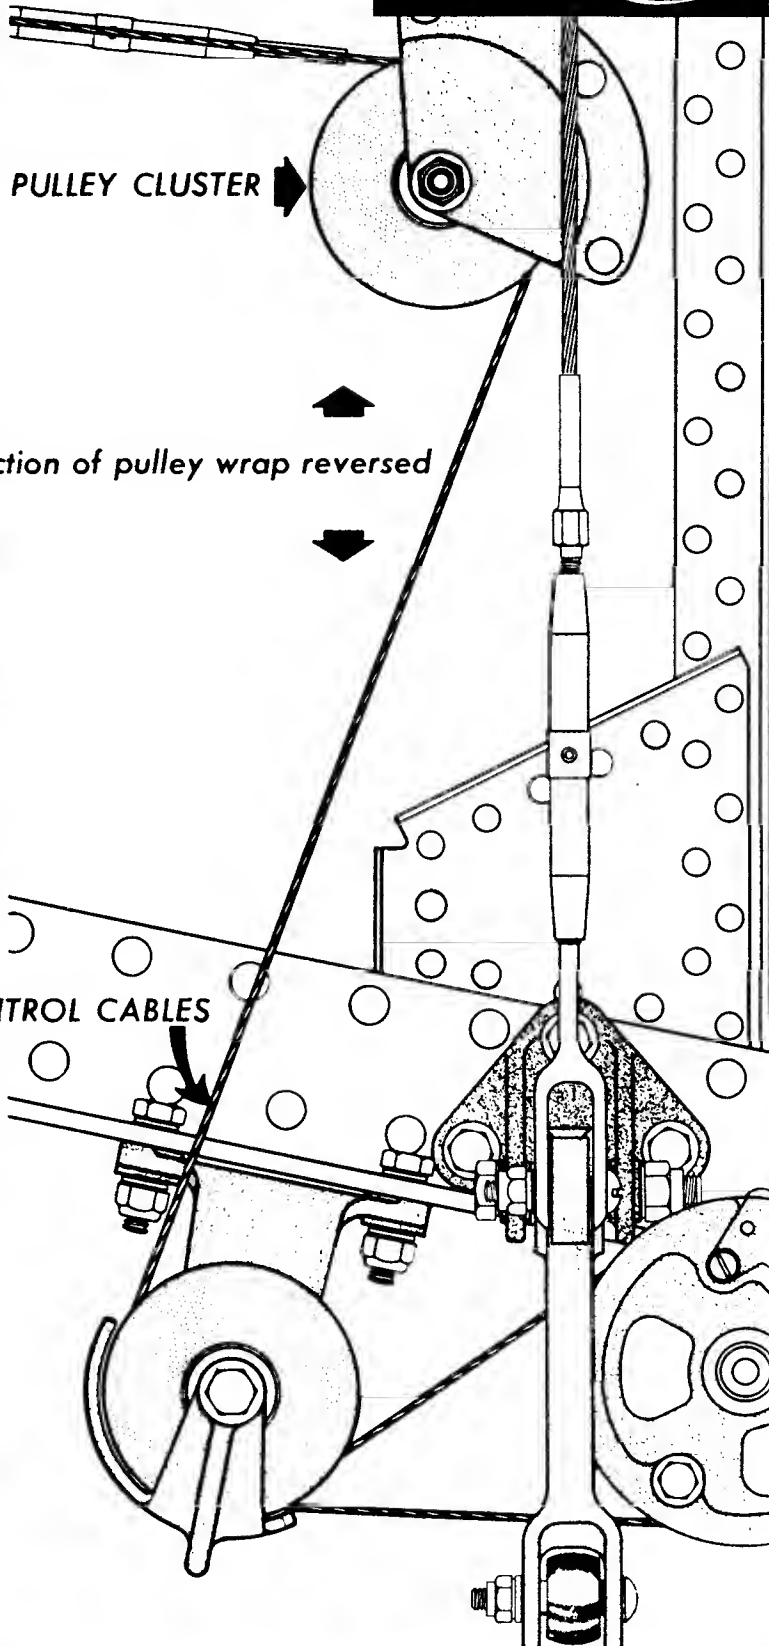
FUEL TANK SHUTOFF CONTROL CABLES

A **BROKEN CABLE** was discovered in the fuel tank valve control system during preflight inspection, the second instance experienced by this airline. Cables in valve control systems of similar aircraft were also found to be so badly worn as to require replacing well ahead of the normal replacement period to be expected of this control system. In all cases, the cables were frayed to the extent of several broken strands in the area where the cables made 120 degree turns around each of two closely spaced pulleys. The cable that failed broke in this place.

Cables frayed in area where direction of pulley wrap reversed

The cable system was designed according to the company's design manual specifications on permissible wrap angle relative to pulley diameter. Nevertheless the cable broke prematurely. It is probable that the abrupt reversal of the wrap from one pulley to the other, resulting from the close spacing of the two pulleys, put the outer strands of the cable under extreme strain. This caused the fine wires to bend back and forth sharply as they passed over one pulley and on to the other, resulting in eventual failure of the strands.

Revision of design manual data pertaining to cable installations is indicated not only in the above instance but wherever premature cable wear is experienced.

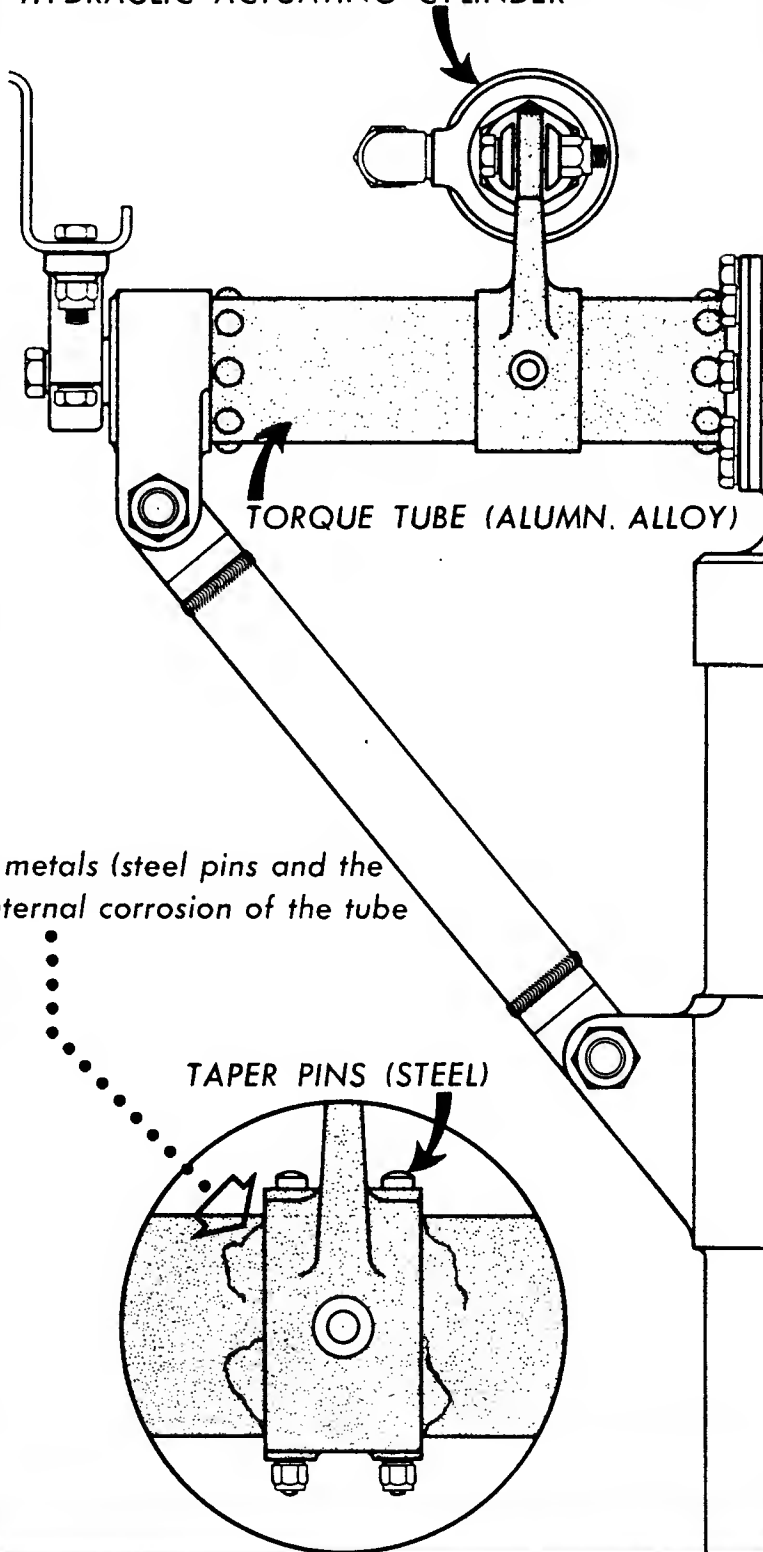
A main landing gear of an amphibian aircraft collapsed on landing. Considerable damage to the structure resulted, and the crew sustained minor injuries from being severely shaken up. Cause of the accident was failure of a torque tube in the retraction mechanism.

The failed torque tube, made of an aluminum alloy, was attached to the retraction actuating lever by steel taper pins. Constant exposure to the corroding effects of sea water produced electrolysis between the dissimilar metals (aluminum and steel) inside the tube where it escaped notice. The internal corrosion progressed to where the tube was weakened sufficiently to fail when landing loads were applied.

Examination of the opposite gear also revealed internal corrosion which had progressed to where failure was imminent.

Electrolytic action of dissimilar metals (steel pins and the aluminum alloy tube) caused internal corrosion of the tube

The aluminum alloy tubes were replaced by welded assemblies consisting of steel tubes, actuating levers, and shock absorber strut attachment flanges.

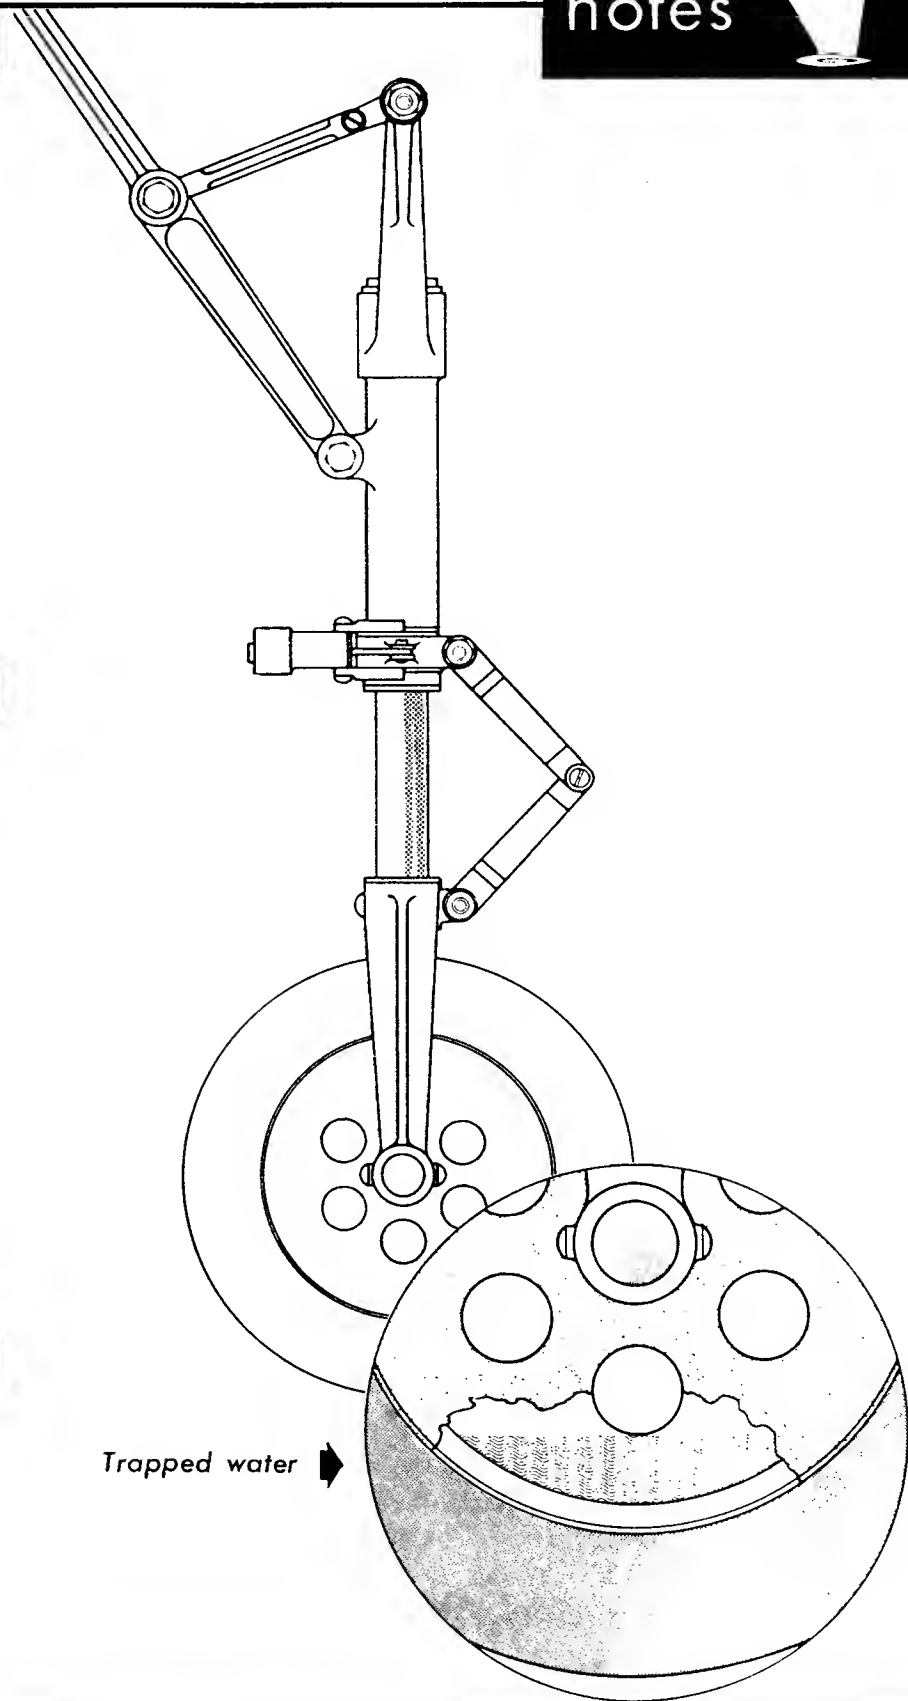
A landing gear nose wheel was designed with a built-in hazard. Because there were no drain holes, a quart of water could accumulate inside the wheel and freeze, or cause unnoticed corrosion.

Ordinarily, aircraft would not experience difficulty in taking off with water entrapped in the wheel. But water frozen into a two-pound chunk of ice would unbalance a nose wheel enough to cause it to shimmy dangerously during high speed landing or takeoff. To cite an incident: Uncontrollable shimmy of an interceptor type aircraft occurred during the high speed landing roll. The severe nose wheel vibration in the horizontal plane had actuated the following circuit breakers: all four fuel boost pump circuits were off; ILS (instrument landing system), gun sight, and the right hand leading edge flap circuits had been deactivated.*

Eight drain holes, 0.125 in. dia, were drilled close to the wheel's outer edge.

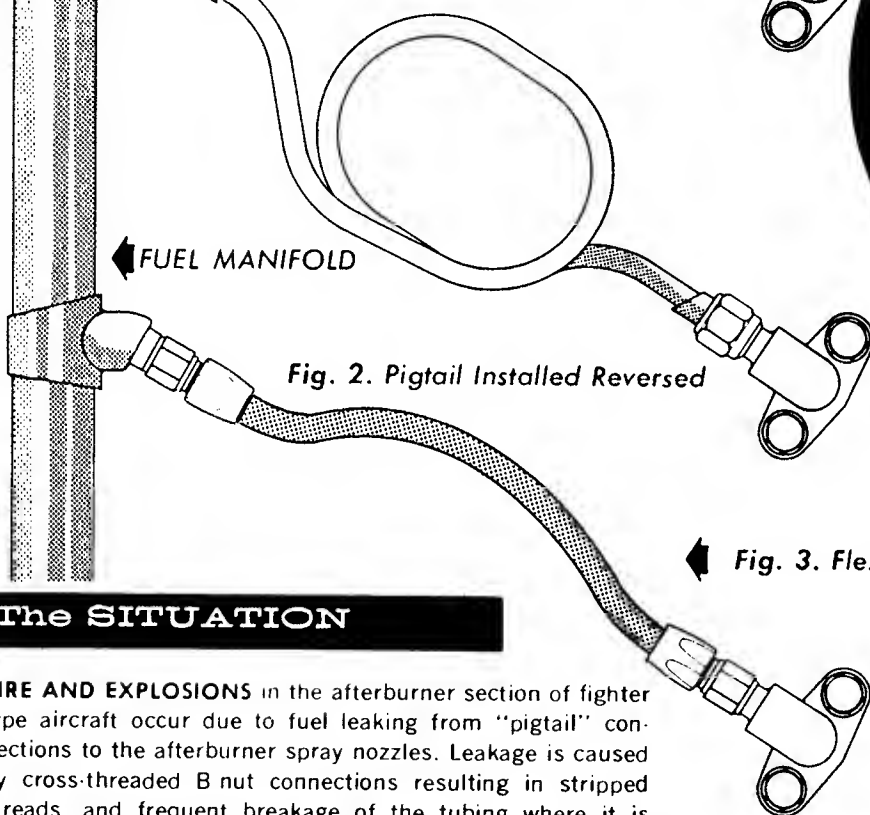
Fig. 2. Pigtail Installed Reversed

BOTH CROSS THREADING OF THE B-NUTS and broken tubing of the pigtail connectors result from the existing misalignment of the spray bar and fuel manifold connections. They are just enough out of line to escape the notice of a mechanic not thoroughly familiar with the situation, and permit the pigtails to be installed in reverse. When this is done, threads are likely to be stripped and the soldered joints crack open due to the excessive bending stress on the joint caused by forcing the tube into place. Each engine has 24 pigtails; 48 chances of a leaky connection.

MUCH OF THE COSTLY DIFFICULTY would disappear if the spray bar and manifold connections were designed to be in line. The pigtails could then be made symmetrical and thereby installed easily without the danger of cross threading.

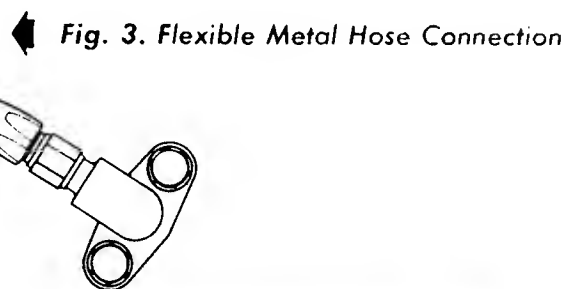
Fig. 3. Flexible Metal Hose Connection

It is not clear why the existing condition could not be alleviated by substituting a flexible metal hose for the present rigid pigtail.

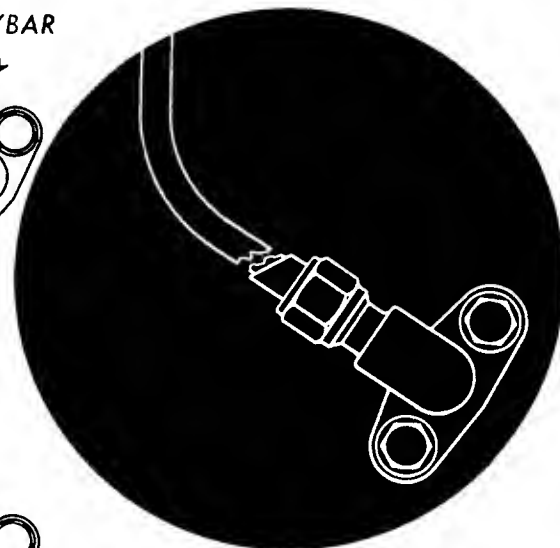
Fig. 4. Typical Break In Fuel Line

FIRE AND EXPLOSIONS in the afterburner section of fighter type aircraft occur due to fuel leaking from "pigtail" connections to the afterburner spray nozzles. Leakage is caused by cross-threaded B nut connections resulting in stripped threads, and frequent breakage of the tubing where it is silver soldered to connector ferrules.*

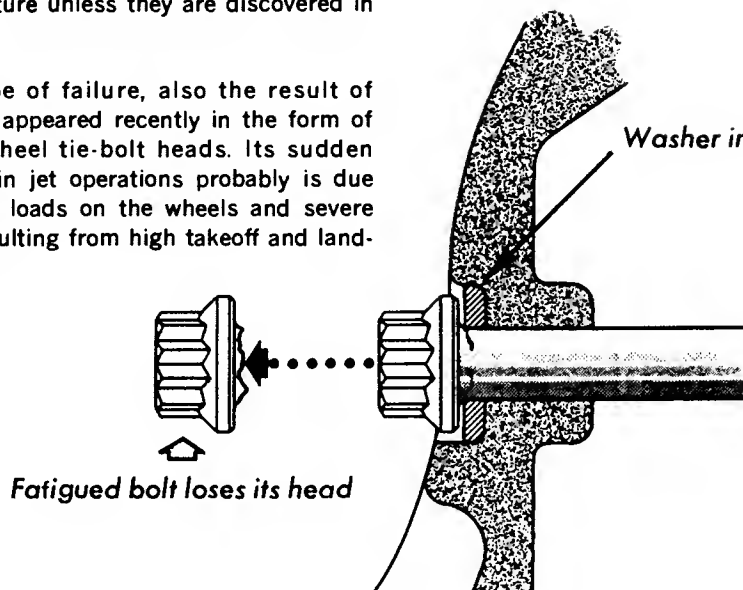
Another type of failure, also the result of fatigue, has appeared recently in the form of fractured wheel tie-bolt heads. Its sudden appearance in jet operations probably is due to increased loads on the wheels and severe vibration resulting from high takeoff and landing speeds.*

Fig. 1 Fatigue Starts In Nicked Radius Of Bolt

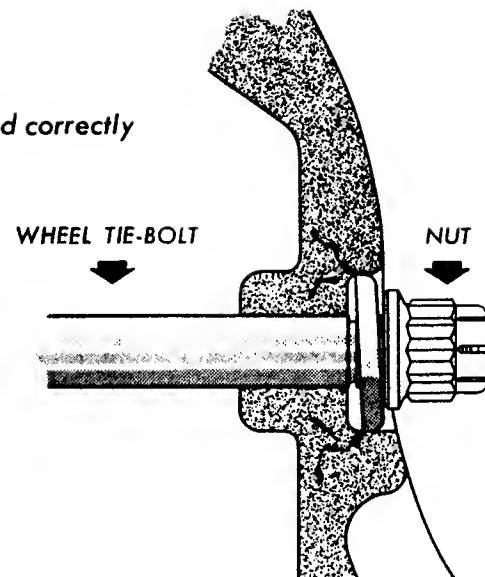
Fig. 2 Improperly Installed Washer

THE WASHERS UNDER THE BOLT HEAD AND NUT are made of thick steel. Ordinarily, one edge is rounded to correspond to the radius of the spot facing surrounding the wheel's tie-bolt holes (the original Design Note advocated rounding both edges of the washers). When properly installed, these washers fit the spot facing radius without damaging the wheel's softer metal. If, however, the sharp edge is jammed into the indentation (Fig. 2), fatigue cracks are likely to start and, because they are hidden under the washers, remain undetected. Also, washers improperly installed under the bolt head, or washers that do not have the edges of the hole relieved (Fig. 1), cause frequent bolt failures. The sharp edge jammed against the bolt head radius nicks the material causing fatigue cracks to start.

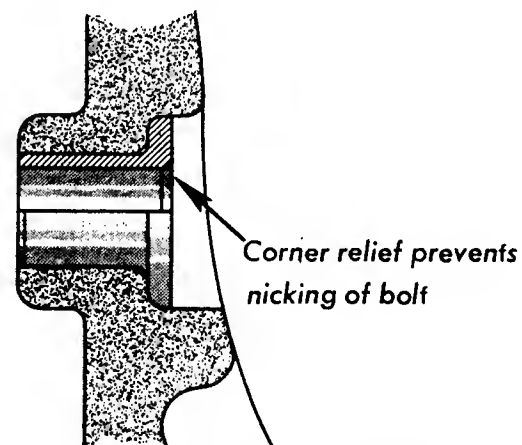
Fig. 3 Steel Insert Eliminates Washers

A POSITIVE FIX for both hazardous situations is shown in Fig. 3. The pressed-in steel bushing does away with many loose parts (washers) and prevents operation of Murphy's Law.† Relieving the hole in the bushing eliminates the cause of bolt head failure.

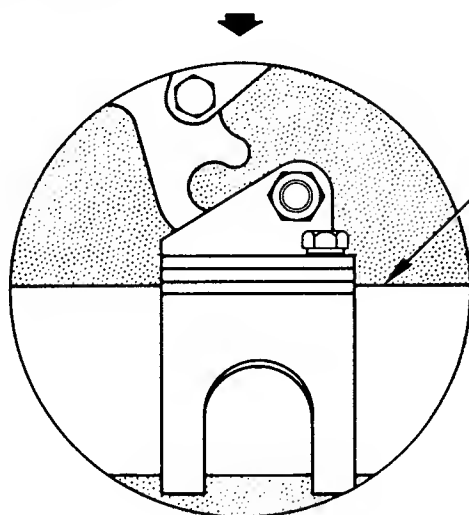
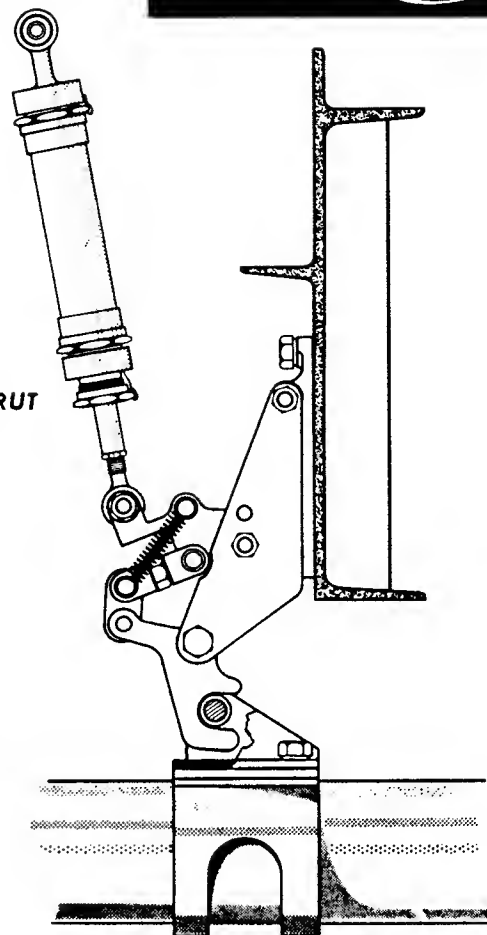
Landing Gear Uplock

A **LANDING GEAR UPLOCK HOOK** failed to engage the latch pin on the strut when the gear was retracted. The reason for the malfunction was discovered in the latch pin fitting; it had been attached to the strut in an upside down position which placed the pin too far from the hook for the two to engage.

SOMEWHERE IN THE MANUFACTURE OF THE PARTS (probably in the design of the tooling), the airframe designer's good intentions were defeated; the mounting pad on the strut was made with four holes arranged symmetrically which allowed the fitting to be attached either way in conformance with Murphy's Law.†

Apparently someone assumed the mounting pad should have four holes instead of an odd number and proceeded to make the hole pattern symmetrical without consulting the design engineer.

Wrong assembly possible

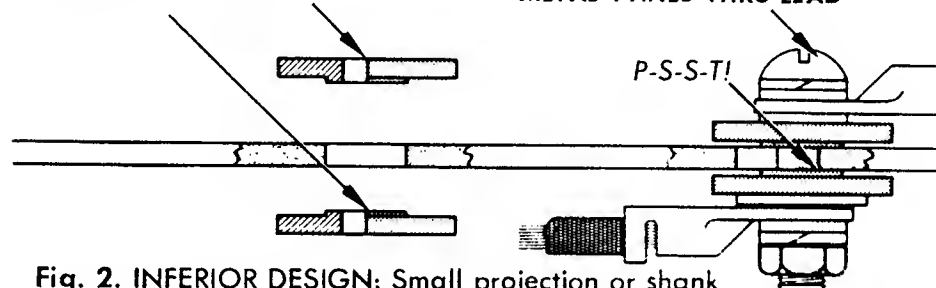
Most of the trouble lies in bushings which fail to prevent live terminals from grounding out (see Fig. 2). This, coupled with the absence of a nut and lockwasher to hold the studs in place after the circuit lead is disconnected, presents an additional hazard.

Fig. 2. INFERIOR DESIGN: Small projection or shank allows bushing to easily slip out of hole in mounting plate. Also, note omission of the retaining nut "A" and lockwasher shown in Fig. 3.

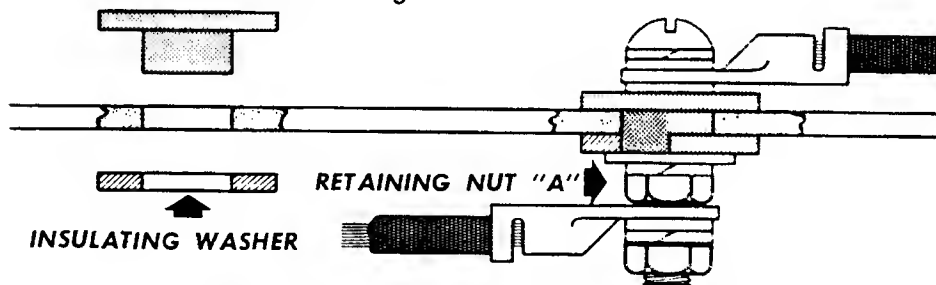
Fig. 3. SUPERIOR DESIGN: Bushing's long shank prevents stud from shifting out of place.

DESIGNED FOR SAFETY, the thru-lead bushings shown in Figs. 3 and 4 have long shanks to prevent them from slipping out of the holes in the metal panels. Insulating washers slipped over the shank of the bushings completely isolate the current carrying portion of the terminals from the grounded metal panel.

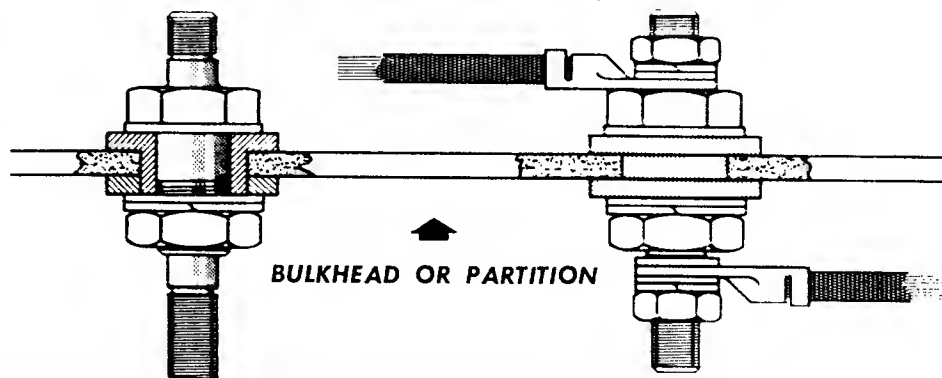
Fig. 4. BULKHEAD THRU-LEAD: Circuits on either side can be removed without disturbing opposite connections.

A thru-lead using the bushing-washer combination shown in Fig. 4 is designed for use in bulkheads or partitions.
